# Sinkhole Analysis and Classification Using Pictometry in Genesee County, NY and Surrounding Areas

A Thesis

Presented to the Faculty of the Department of Environmental Science and Biology  
of the State University of New York College at Brockport

December 2015

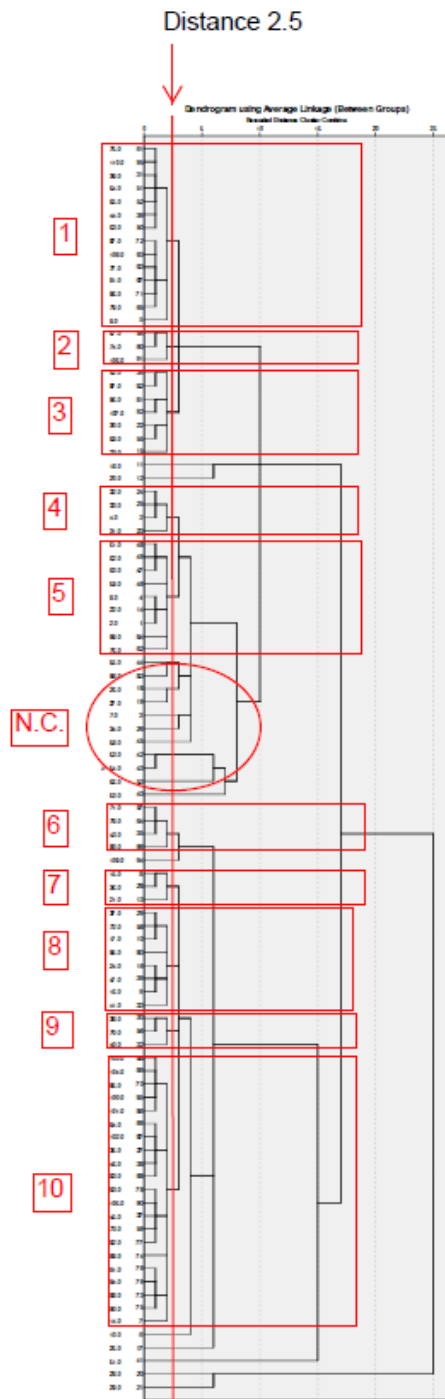
Figure 1. Annotated dendrogram of distance 2.5 clusters, using a minimum of three cases to define a cluster. This clustering result allows for the differentiation of 10 distinct groups of sinkholes characterized by certain parameters.

Clusters were created in SPSS 22 using the hierarchical clustering method, with a between-groups linkage and squared Euclidean distance; no data standardization was used. Several combinations of the aforementioned variables were assessed, yet most produced little to no clustering of sinkholes. Different combinations were tried to determine if any potential relationships between the parameters occurred. For this data set, the only set of parameters that provided reasonable clustering were clusters based on Target Soil Presence/Absence, Sinkhole Shape, Sinkhole Size, Land Use, Moisture Content, Main Characteristics, Land/Water-Based, and Visibility of Sinkhole within Pictometry. A distance of 2.5 was used to separate the clusters, while a minimum of 3 cases were needed to be considered a cluster. The distance of 2.5 corresponds to a within-cluster data similarity of 97.5%; this level was chosen to ensure that a majority

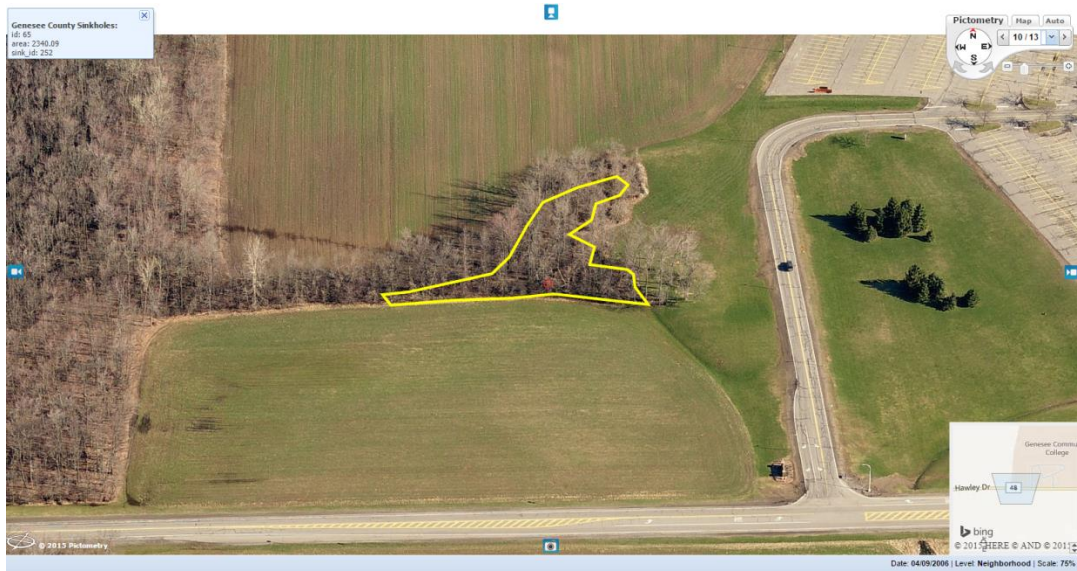
Figure 2a. A dry period time-step for Sinkhole #65 located on the campus of Genesee Community College in Batavia, NY. Although a drier period, some water is still evident flowing into the feature from the west.

The representative sinkhole for Cluster #1 is Sinkhole 65, located on Hawley Dr. on the campus of Genesee Community College in Batavia, NY. #65 was not an evident sinkhole in Pictometry, even with contours enabled, unless a snowmelt event was noted during the time series (Figures 2a & 2b). In dry time-steps, this sinkhole appears to be a stand of trees in the middle of a field. During presumed snowmelt time-steps, this feature becomes the center of water flow from at least three surrounding directions,

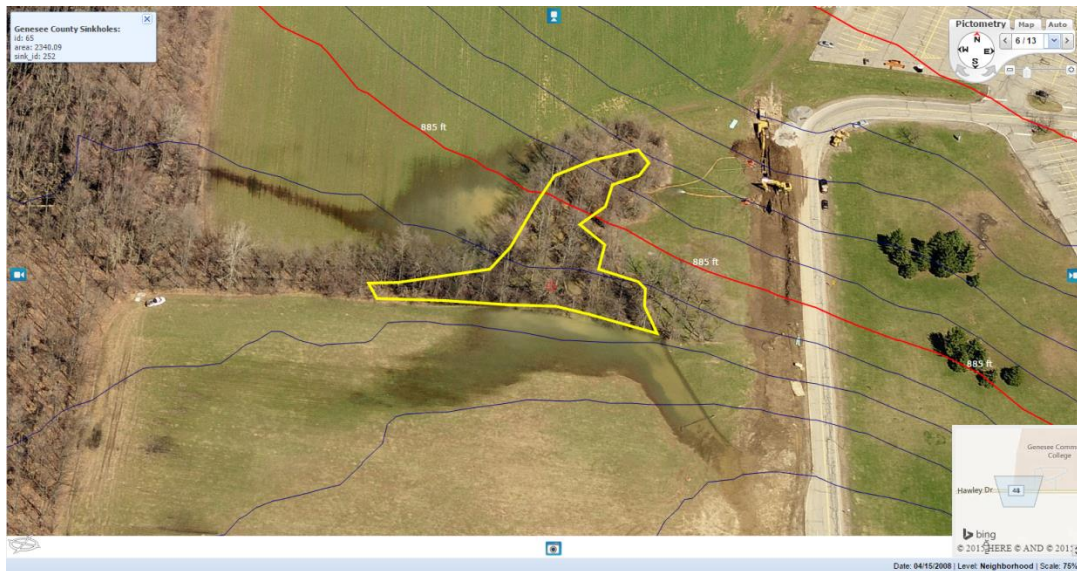
Figure 2b. A wet period time-step for Sinkhole #65 located on the campus of Genesee Community College in Batavia, NY. Water flows are evident coming in from both the west and from the south-east. Due to the amount of water and the time of year, this is a presumed snowmelt event. Of note here is that this sinkhole crosses contour boundaries; this suggests that the micro-topography represented by these contours was not accurate at the time of this map's creation.

with water inundating the tree stand and ponding up all around it. Pictometry contours appear to be a problem on this site, with a gradient from the northeast to the southwest; this gradient crosses over the sinkhole feature with a 6-7 ft change in elevation from one side of the feature to the other. Mapping the moisture boundaries for the ponding that takes place, it becomes apparent that the contours are mapped wrong on this small scale feature since they cross the assumed constant height of the water surface. This becomes one of the rare cases where mis-mapped contours can become a deterrent to finding depressions (and thus potential sinkholes) using Pictometry.

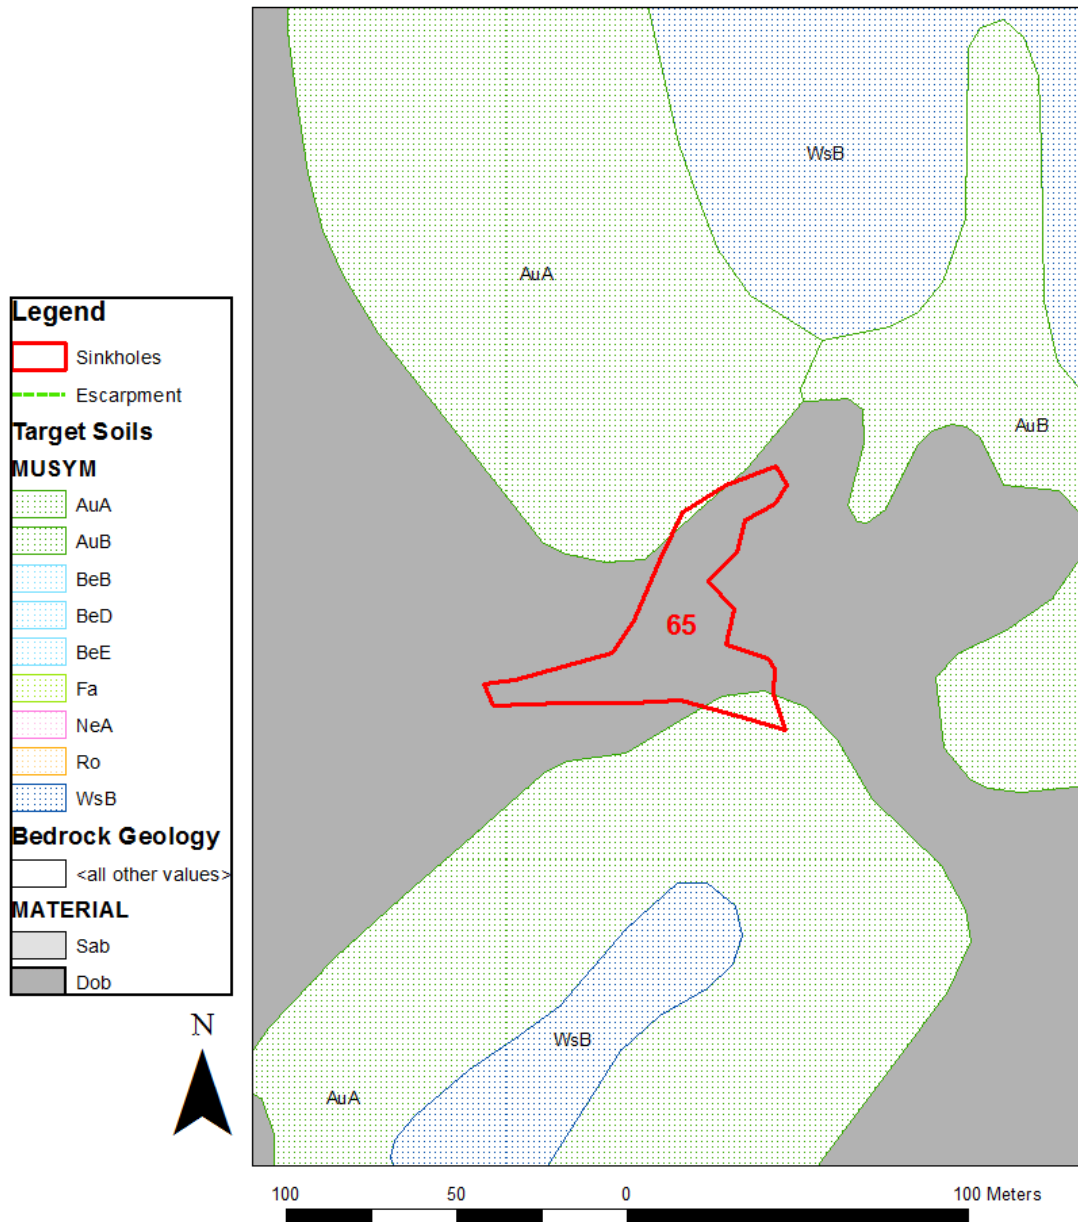
## Sinkhole #65

Figure 2c. GIS-based map product of Sinkhole #65. This sinkhole classifies as ‘contains target soils’ due to the overlap of the feature boundary with that of the target soils – specifically, the Aurora group. This is an erratic-shaped, small-sized sinkhole within the Onondaga Formation.

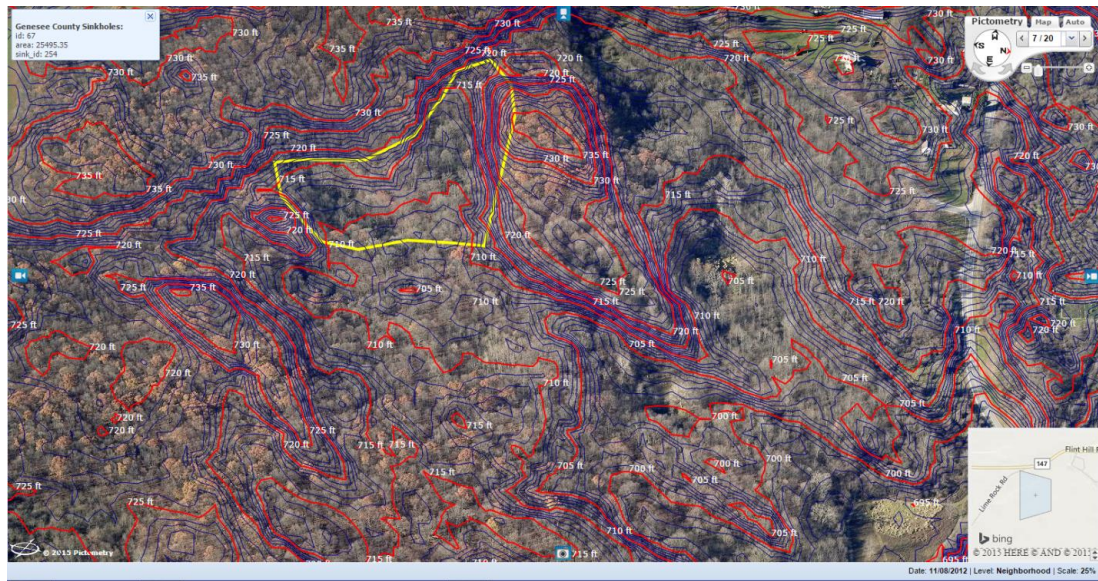
Figure 3a. Sinkhole #67 lies in a significant depression, although only falls in part of it. The sinkhole boundary crosses several contours over an elevation change of 20+ feet; this is either an error in the contour mapping or an error in the sinkhole mapping from prior studies. View from east.

The representative sinkhole for Cluster #2 is Sinkhole 67, located off of Lime Rock Rd. in Mumford, NY, just over one kilometer outside of Genesee County. #67 is generally not evident in Pictometry, due to being covered with trees; however, a couple dips in canopy height can be observed in the feature. These dips, however, are also seen in the surrounding, non-sinkhole area and thus cannot be considered a solid visual indicator of a sinkhole. With contours enabled on this site (Figure 3a), it does become evident that this site lies in part of a significant depression in the landscape. The western edge of the sinkhole feature appears to cross over 20+ feet in elevation; this is either an error in sinkhole mapping or an error in contour creation. In some spring time-steps (Figure 3b), this site appears to have some dark spots in it; whether this is shadow, moisture/water, or something else is un-determined. If it is water (likely due to a snowmelt in this case), it is a piece of visual evidence that a sinkhole (or at least a depression) is present in this site, beyond just the contour analysis.

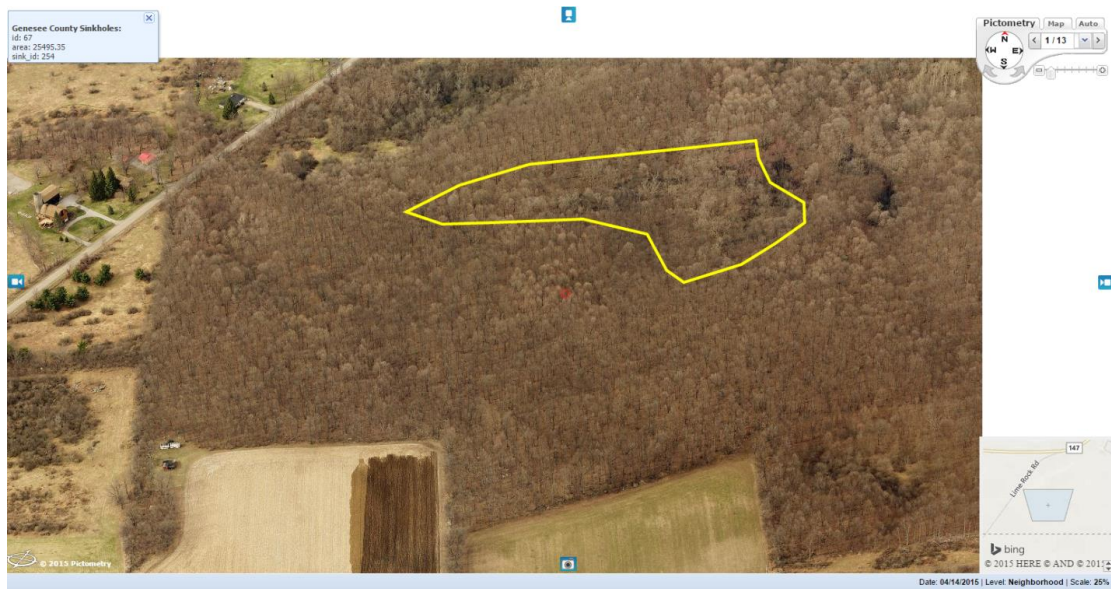
Figure 3b. A mostly dry time-step for Sinkhole #67. This time-step does show some anomalies in the far eastern reaches of the feature. These are dark regions that could be caused by a number of things – shadows, moisture/water, or darkened soils. This is one of the micro-features that are tough to discern in Pictometry.

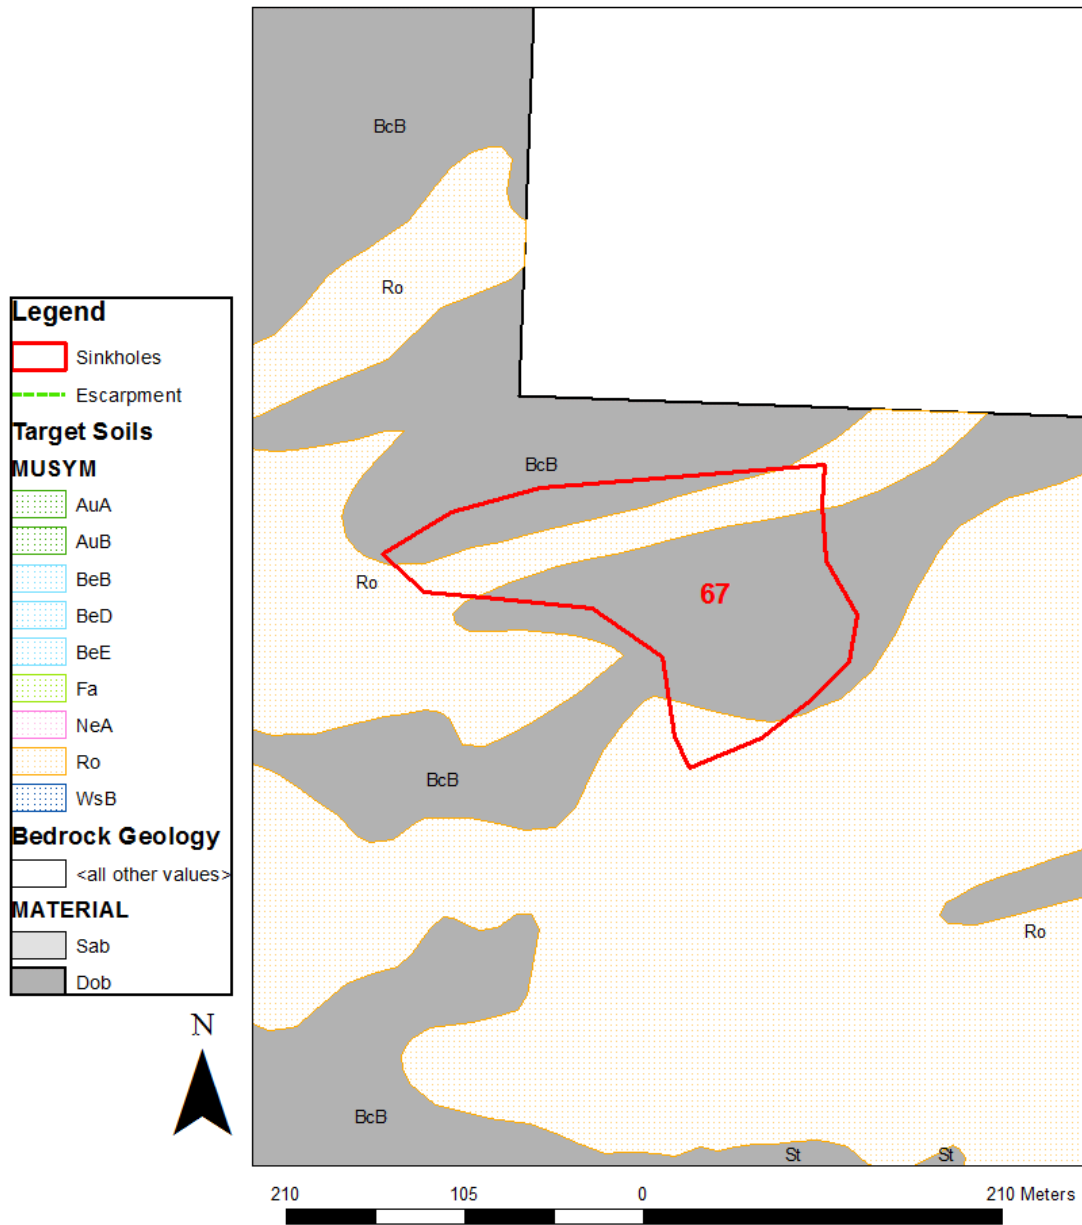
## Sinkhole #67

Figure 3c. GIS-based map product for Sinkhole #67. This feature contains target soils, specifically, Benson and Rubbleland. This feature is an erratic-boundary, moderately-sized sinkhole within the Onondaga Formation.

#67 lies completely within the Dob geologic formation (Onondaga Formation) with Ro target soils in and around it (Figure 3c). Part of this sinkhole is absent of target soils. Of note for this sinkhole is the location of the aforementioned dark regions, which may be moisture. These match up well with the areas of the sinkhole that are absent the thin, target soils. This makes sense, since a thin soil would likely allow for quicker

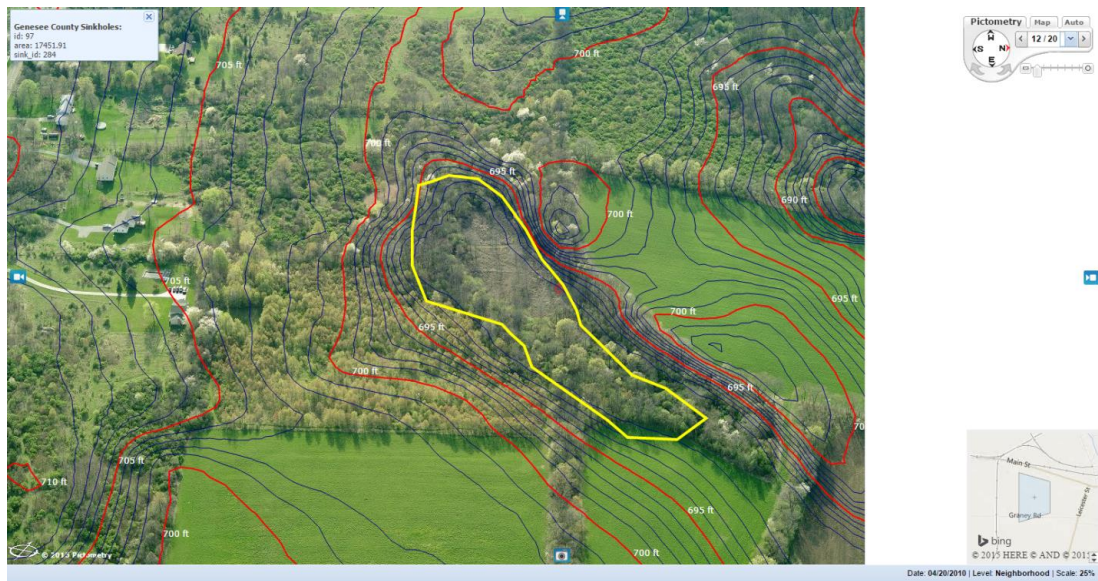
Figure 4a. This is dry-period time-step of Sinkhole #97 in Caledonia, NY. This feature is a very evident sinkhole feature, lying nicely within the contours. It appears to be a dry pond basin, possibly a vernal pool that refills with snowmelt. View from the east.

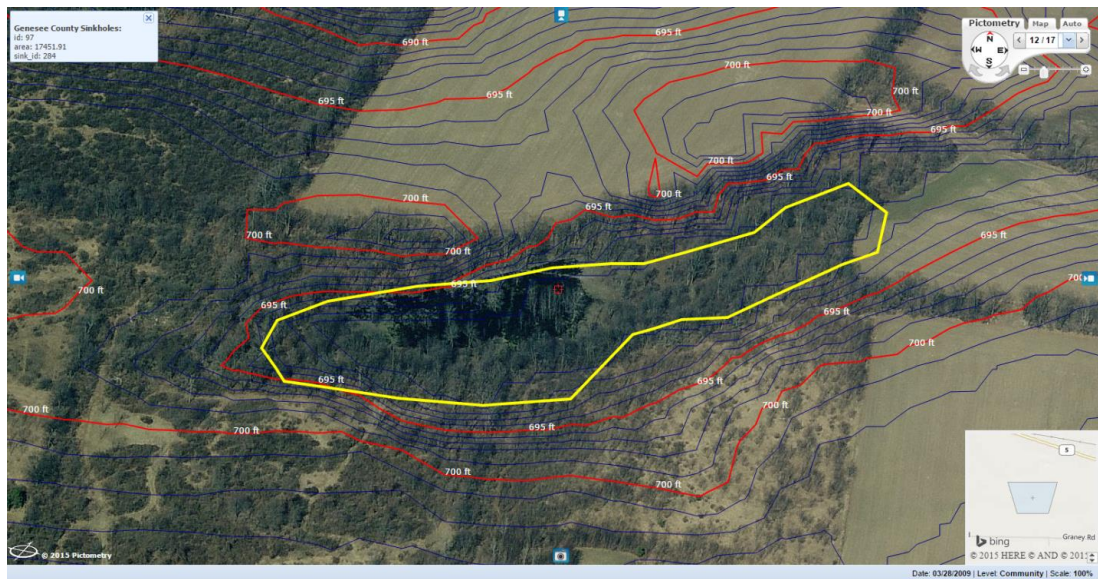
Figure 4b. A wet-period time-step for Sinkhole #97. This shows the pond basin filled with water from a likely snowmelt event. This time-step further enhances the probability that this is a vernal pool sinkhole.

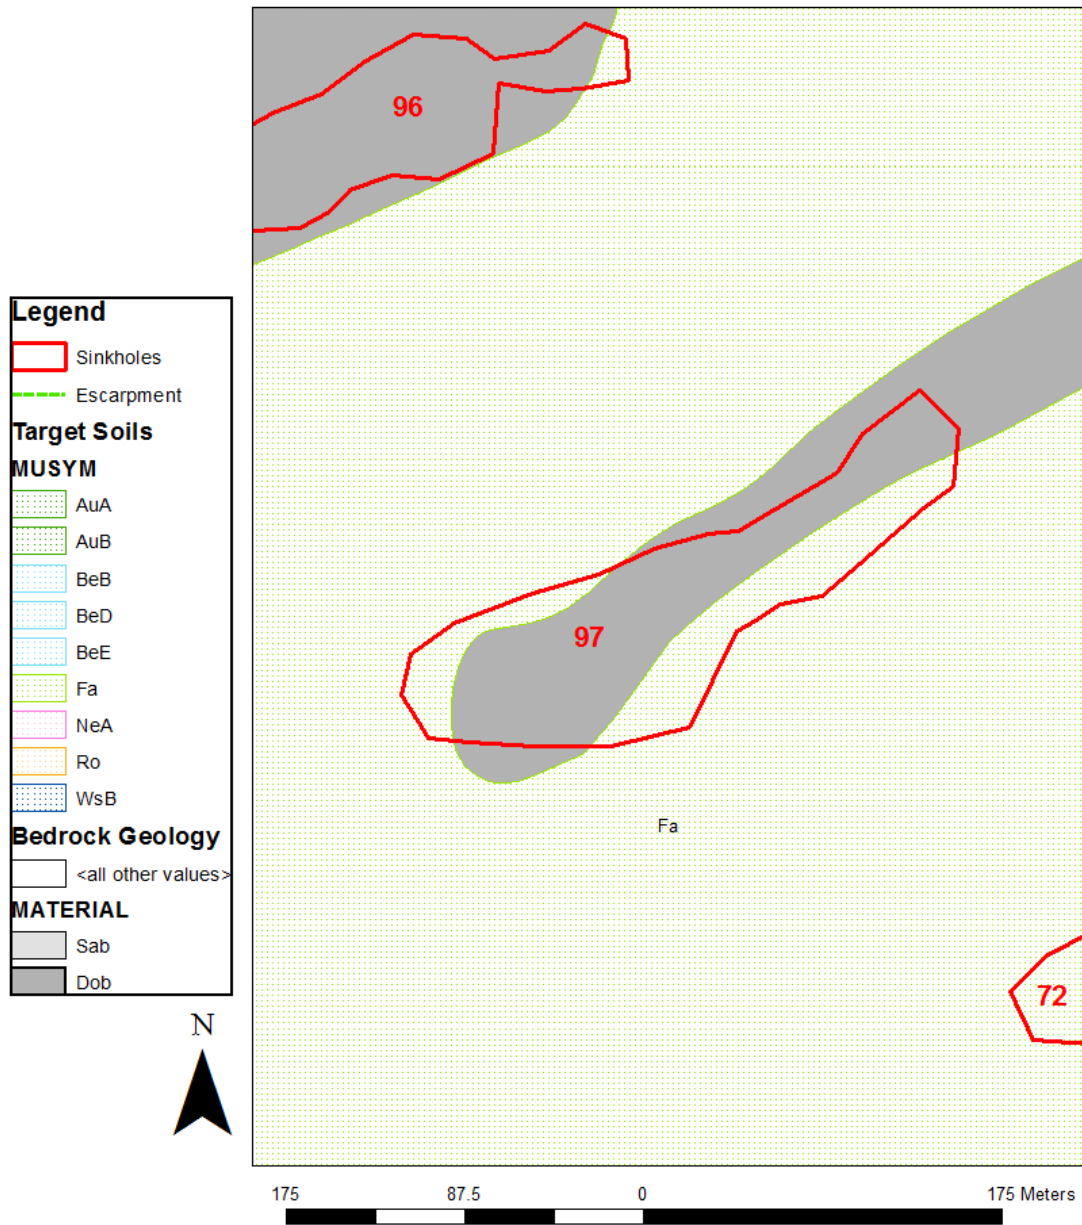
## Sinkhole #97

Figure 4c. GIS-based map product for Sinkhole #97. This shows the feature itself containing shallow soil – from the Farmington group; it is not initially classified as a target soil in Genesee County; however, it is certainly a shallow-to-bedrock soil interacting with karst features.

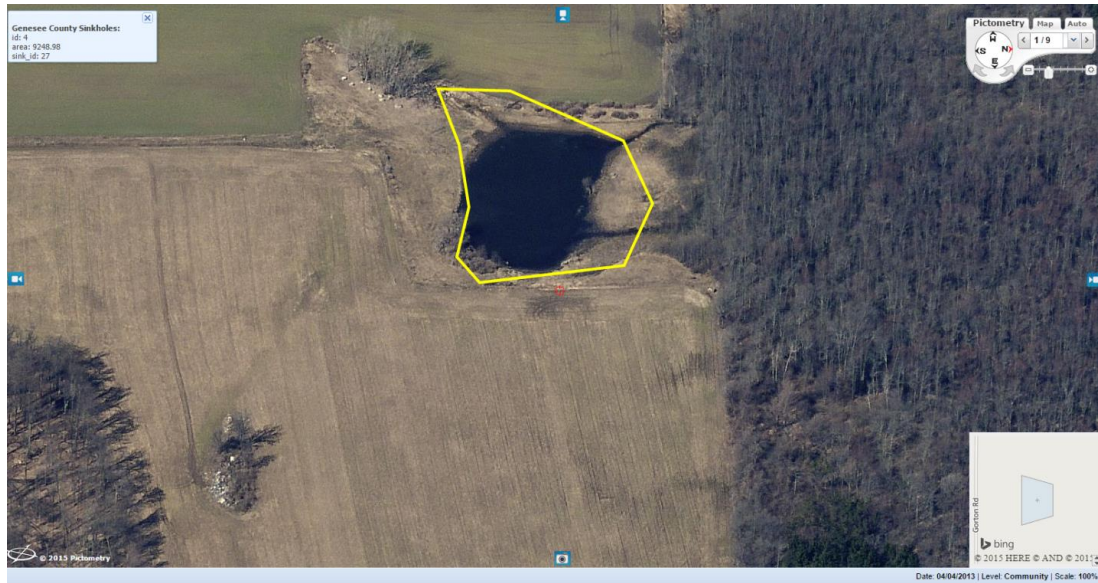
Figure 5a. Sinkhole #4 in Corfu, NY. Two pond outlets located on right side of pond (north). Small temporary inlet is present coming out of the rock spoil pile to the west (top) of the image. This inlet feature is not present in all time-steps of Pictometry. View from east.

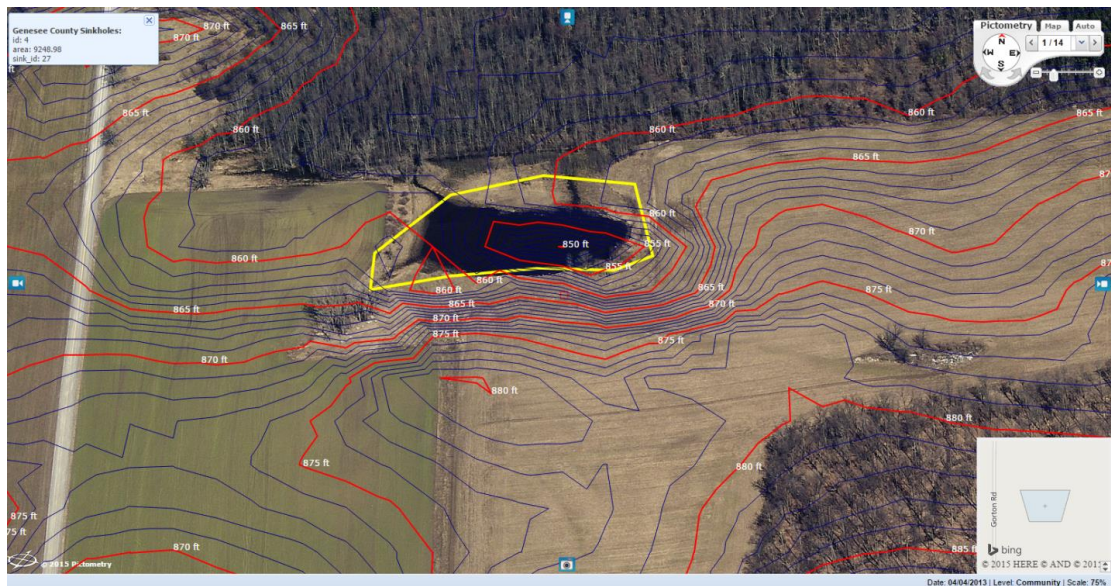
Figure 5b. Sinkhole #4 is a small, smooth-shaped feature. Two spoil rock piles with sub-angular boundaries are visible upslope of the sinkhole. This feature is permanently inundated with water, and is the basin for runoff from the upslope fields.

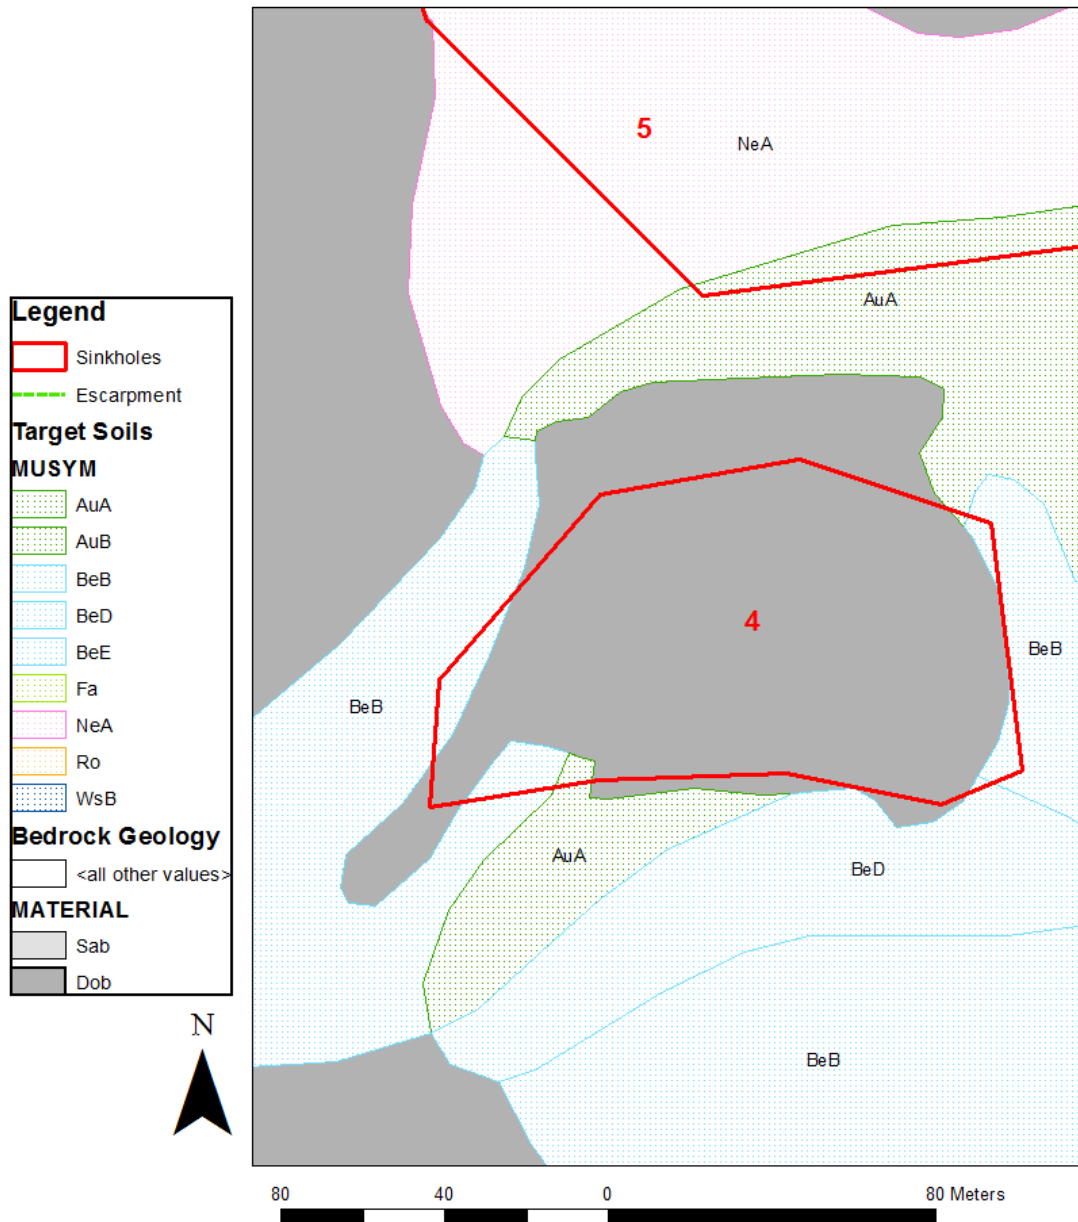
## Sinkhole #4

Figure 5c. GIS-based map product for Sinkhole #4. This is a smooth, small-sized feature in the Onondaga Formation. This contains target soils, albeit barely – both Aurora and Benson groups are present.

The geology of #4 is the sinkhole feature laying completely within the Dob geology (Onondaga Formation). Target soils nearly completely surround this feature yet only barely appear inside of the feature (mainly due to this feature being a pond) as seen in (Figure 5c). The target soils observed in and around this feature are the AuA, BeB, and BeD soils of the Aurora and Benson groups. One last thing to note about this feature is that not far north from it is another sinkhole feature (Sinkhole #5), and the overland flow from #4 outlets directly leads into it.

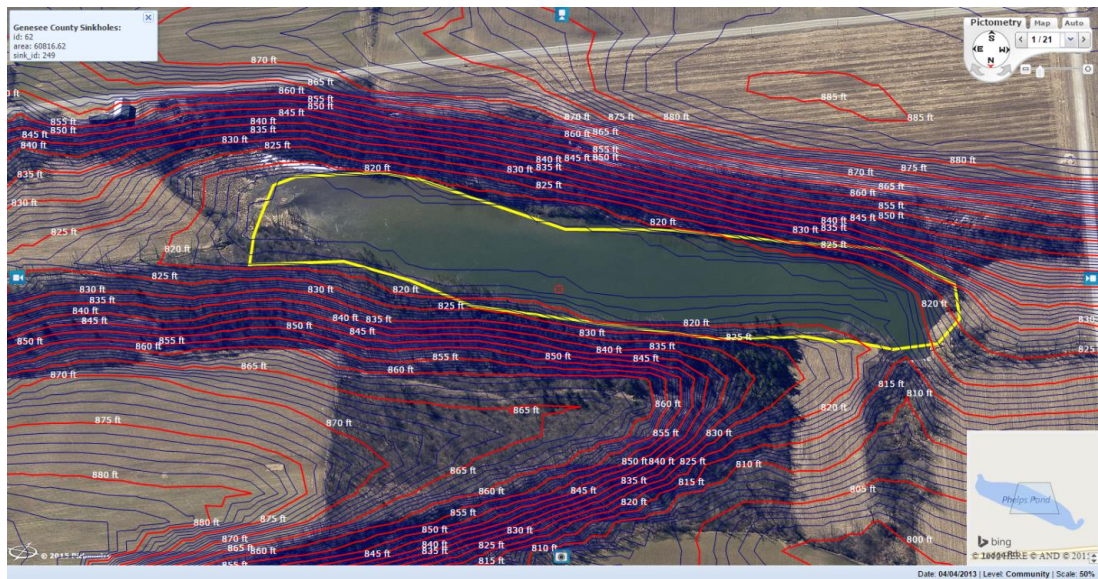
Figure 6a. Sinkhole #62 in Oakfield, NY encompassing Phelps Pond with contours enabled. This shows the steep slopes leading into Phelps Pond, with surrounding wooded regions and farm fields nearby. This is a large natural basin for runoff to accumulate in. Surrounded by farm fields around most of the feature, this is a likely candidate for increased pollution of the groundwater table.

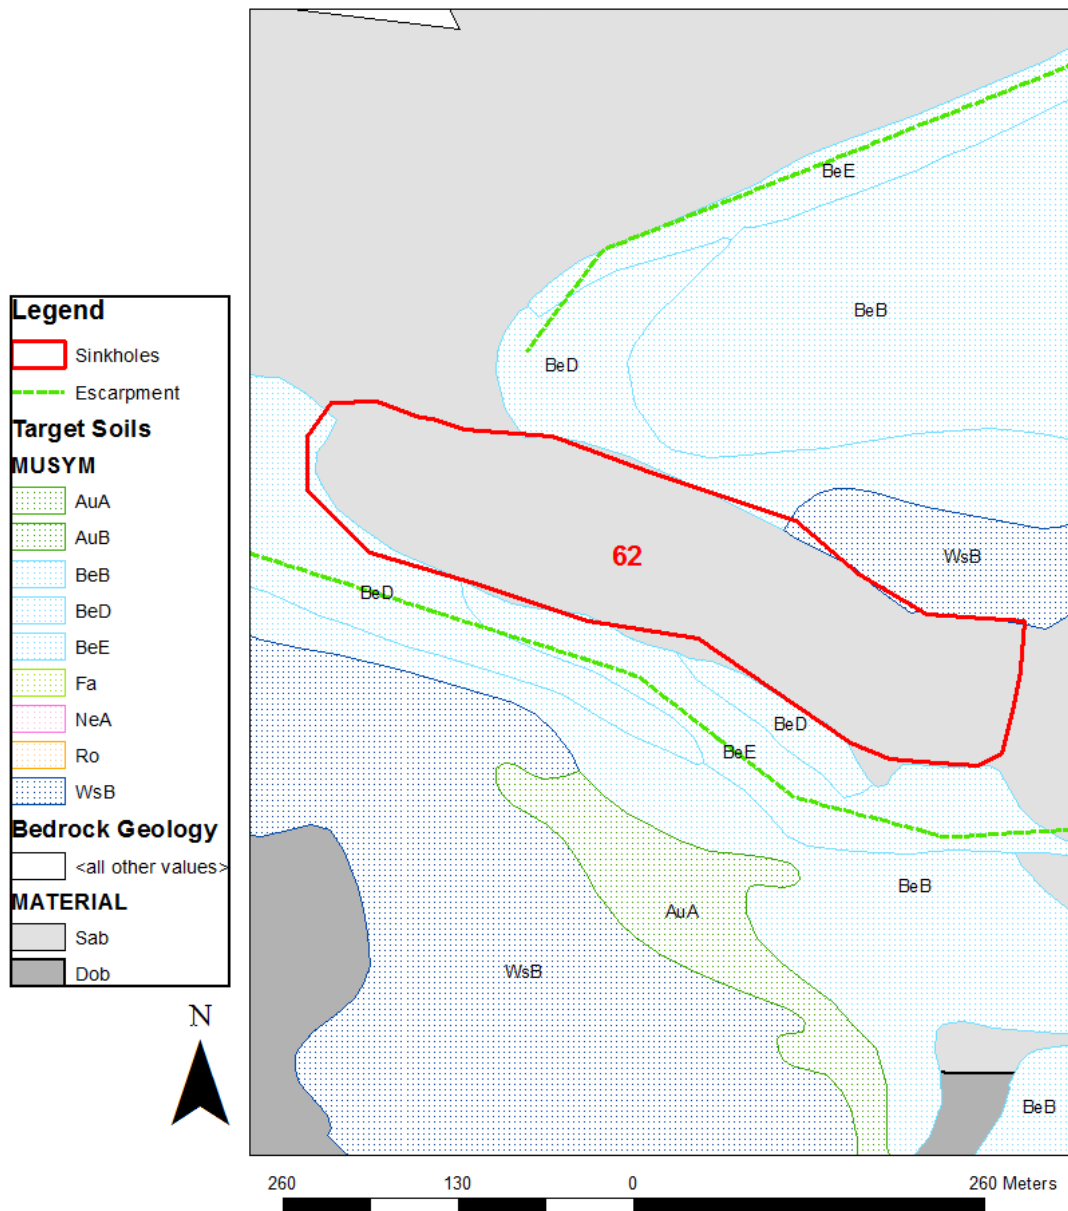
## Sinkhole #62

Figure 6b. GIS-based map product for Sinkhole #62. This smooth, moderately-sized sinkhole lies almost perfectly within a gap in the target soil, although it does slightly overlap – This gap is due to the water from the pond itself. It does have inclusion of the Benson group soil. This feature lies extremely close to the Onondaga escarpment, being just north of the feature, within the Akron-Bertie Formation.

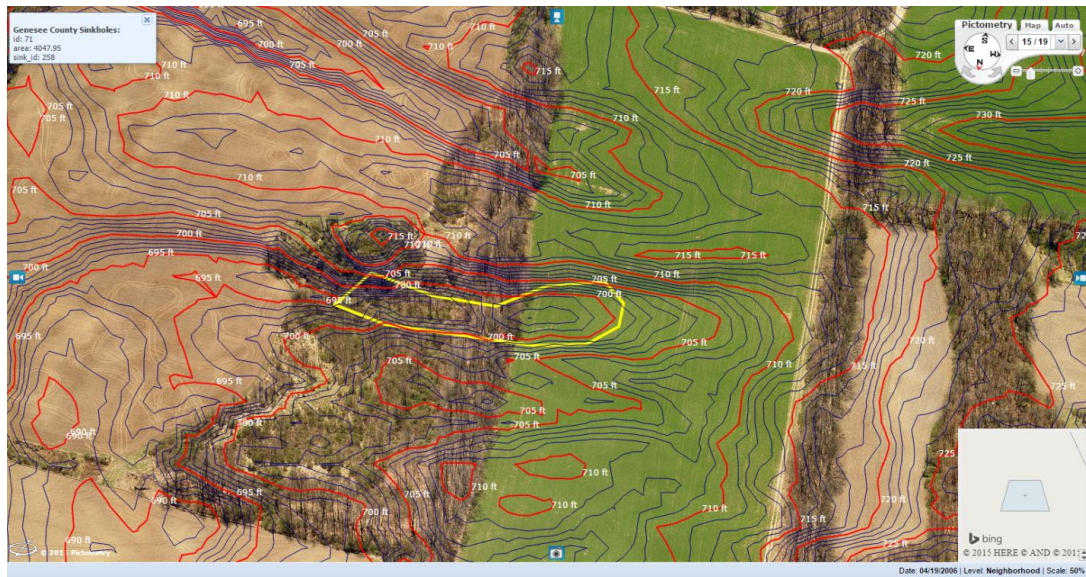
Figure 7a. Sinkhole #71 in Caledonia, NY. Pictometry with contours denoting two ridges parallel to the long axis of the sinkhole within the farm field portion of the feature. This smooth, small-sized feature is a funnel for the upslope farm field runoff. View from north.

The representative sinkhole for this cluster is Sinkhole #71, roughly 750 meters north of Rt 5. in Caledonia, NY in Livingston County. In Figure 7a from Pictometry, ridges within the field, parallel to the long axis of the sinkhole, are evident - noted by

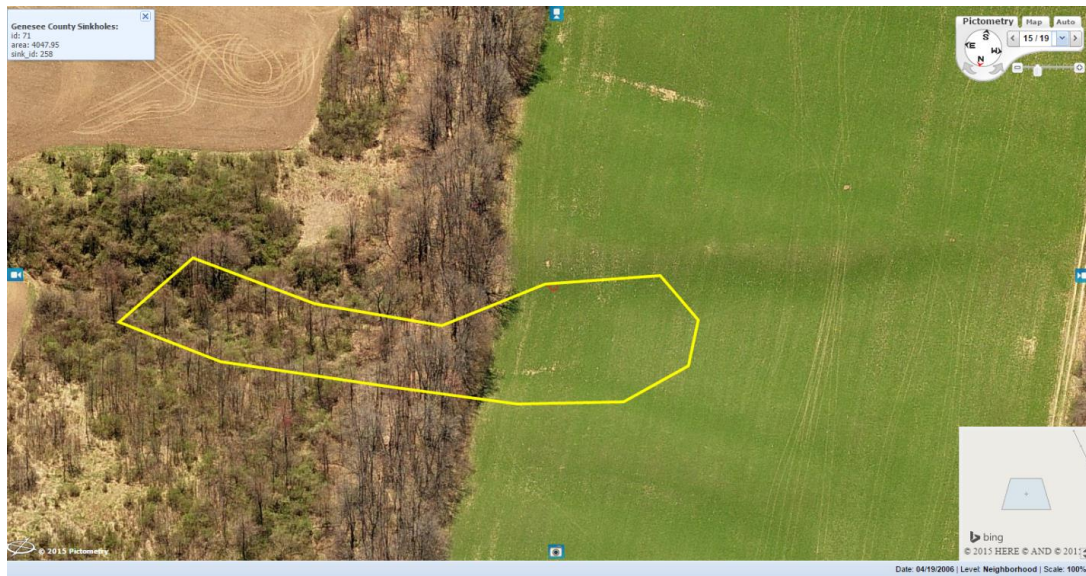
Figure 7b. Sinkhole #71 Pictometry view from north; zoomed in to show boulders and sub angular rocks scattered through the farm field. These sub-angular rocks are indicative of shallow depth-to-bedrock and karstic terrain.

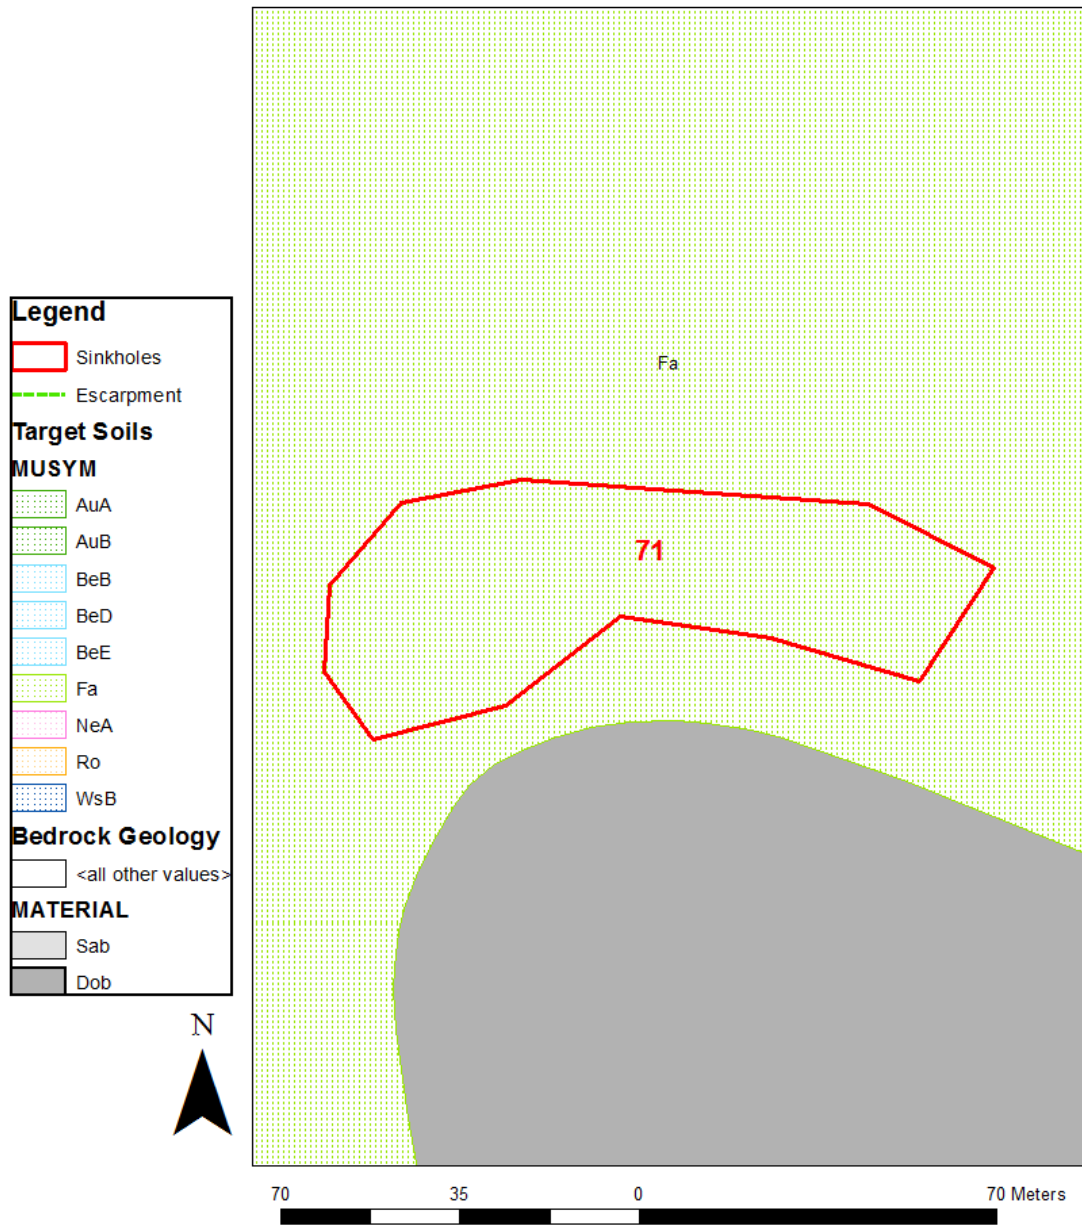
## Sinkhole #71

Figure 7c. GIS-based map product of sinkhole #71. This sinkhole is within the Onondaga Formation. This shows the feature laying completely within the Farmington group soil; although not a target soil by definition, it is a shallow soil that lies over karst terrain.

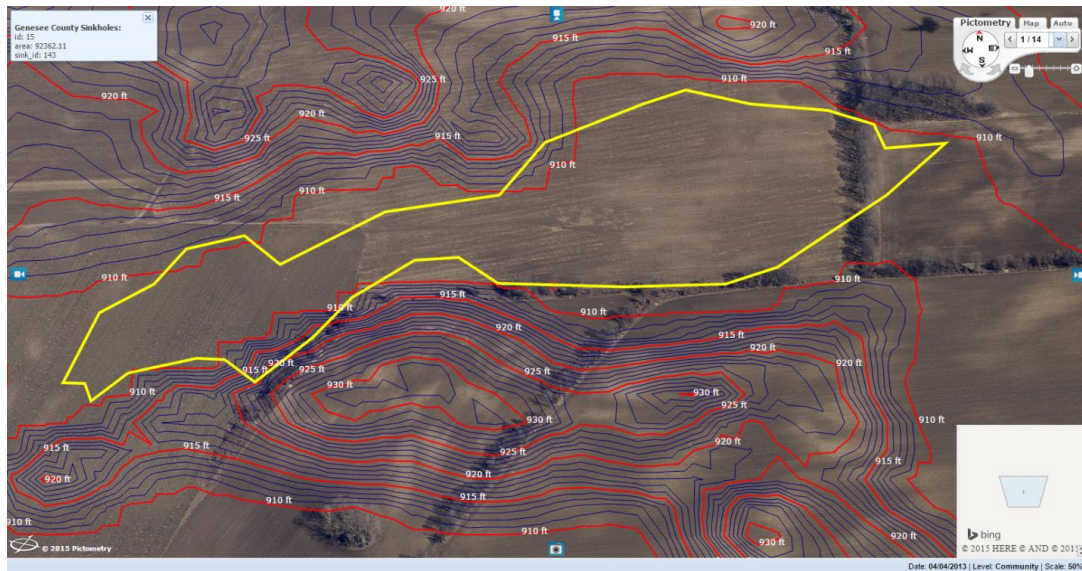
Figure 8a. Sinkhole #15 in Batavia, NY. This is from a dry time-step. The feature lies within a nice low-point in the contours within this farm field. Evident is slight soil discoloration, hinting at potential soil-type changes or differences in moisture content.

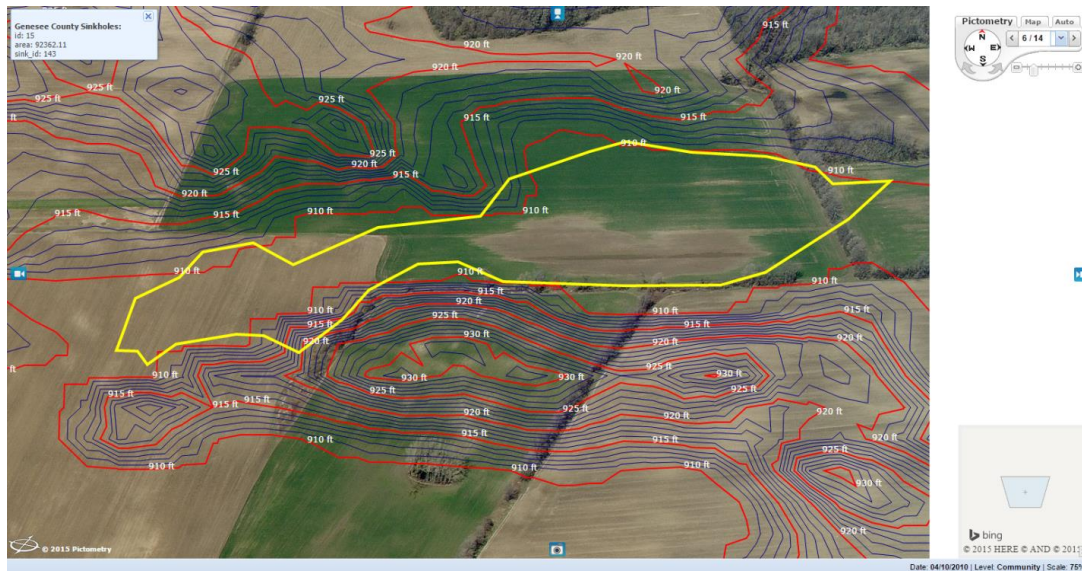
Figure 8b. Sinkhole #15 during vegetation growth period. A barren spot is located within the sinkhole, likely due to increased moisture prohibiting plant growth.

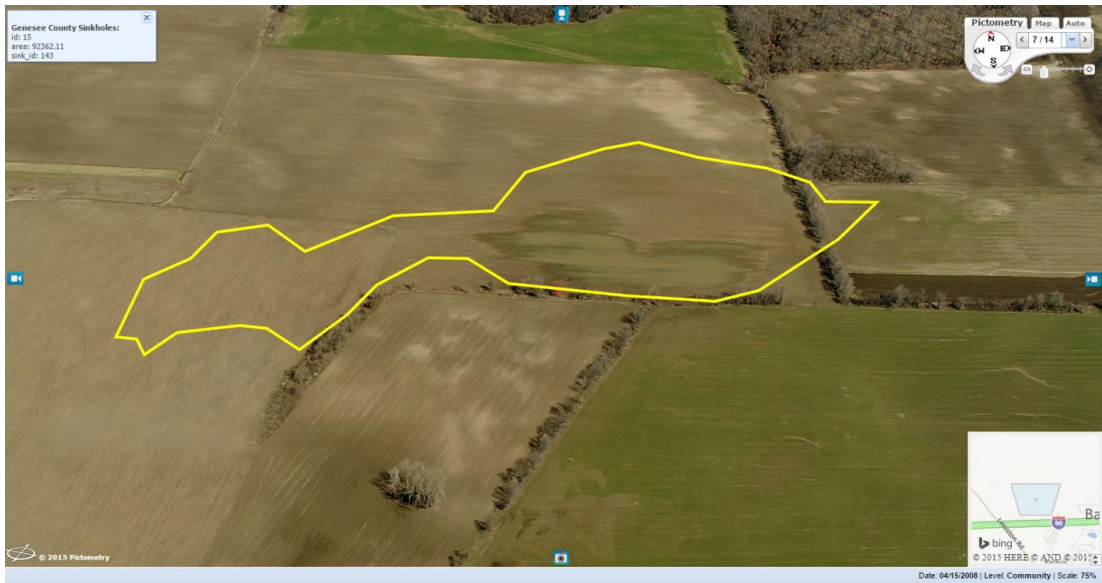
Figure 8c. Moist time-step for Sinkhole #15. Spring snowmelt has resulted in a temporary lake appearing in the middle of this sinkhole feature. This moist location matches the absent vegetation location from the prior figure.

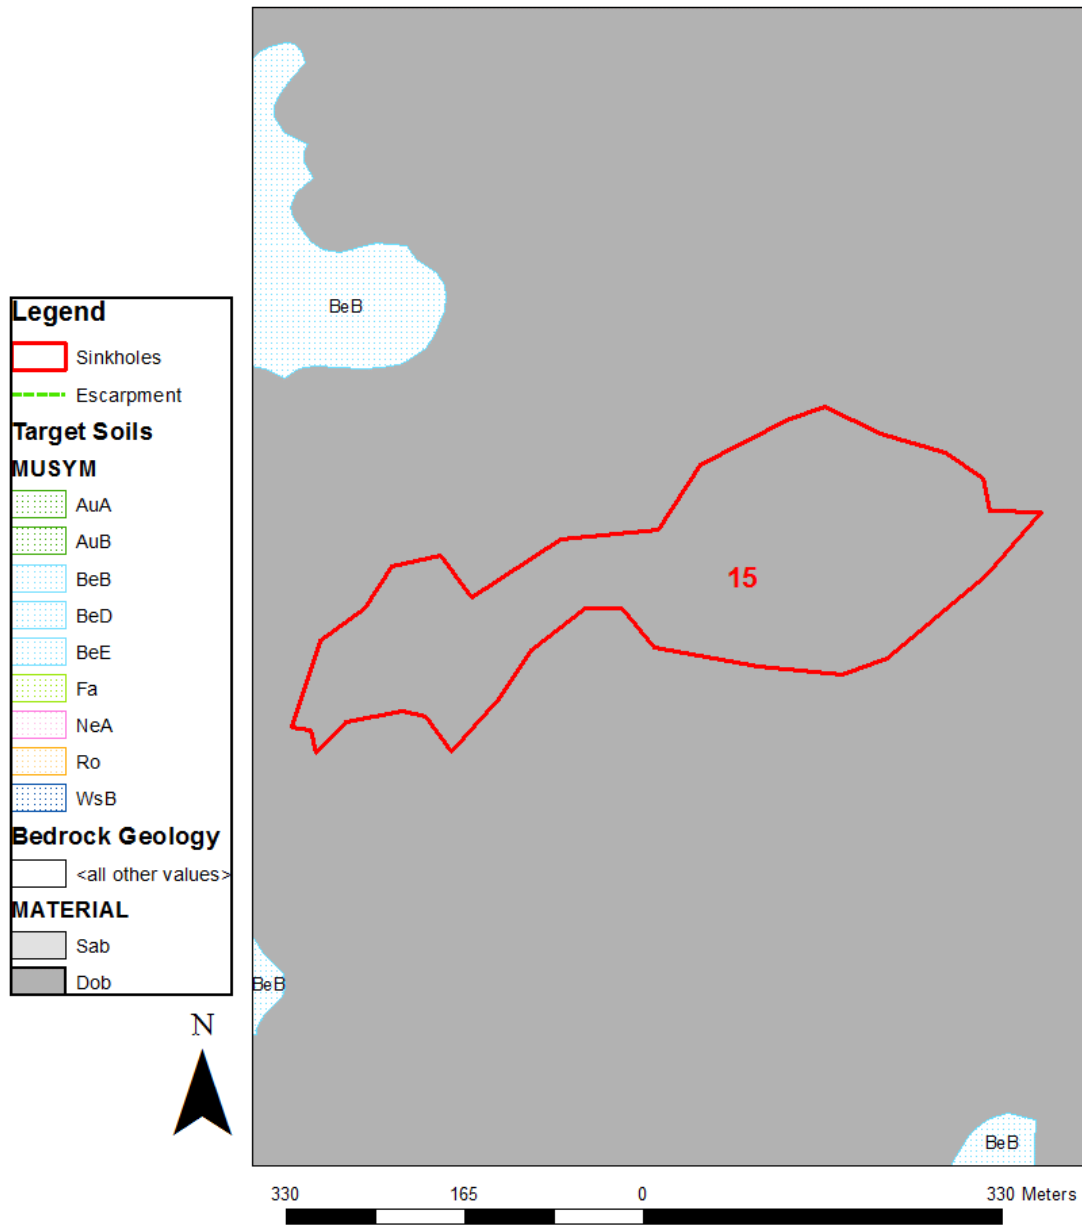
## Sinkhole #15

Figure 8d. GIS-based map product for Sinkhole #15. This feature is within the Onondaga Formation and is absent of target soils. It is an erratic boundary feature that is moderately-sized.

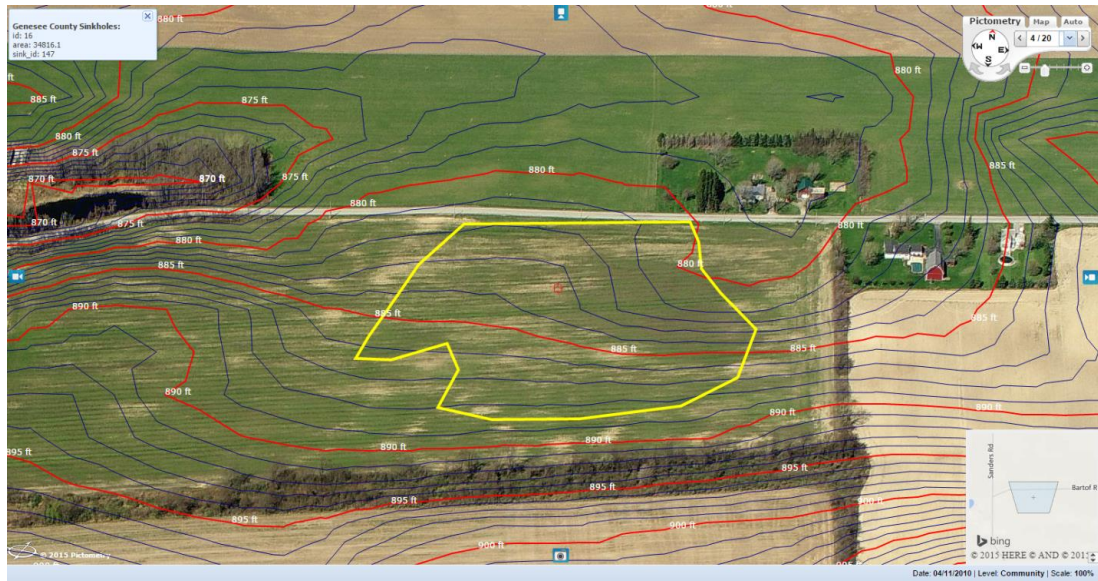
Figure 9a. Sinkhole #16 located on Bartof Rd. in Stafford, NY. This is a classic shallow depth-to-bedrock sinkhole feature. The feature itself crosses contours but has micro-topographic depression features throughout that collectively comprise the sinkhole.
